**Flood Control Project Maintenance
Levee Inspections**

Fall 2015 Levee Maintenance Deficiency Summary Report

Reclamation District No. 0307 Lisbon

Unit Cover Sheet

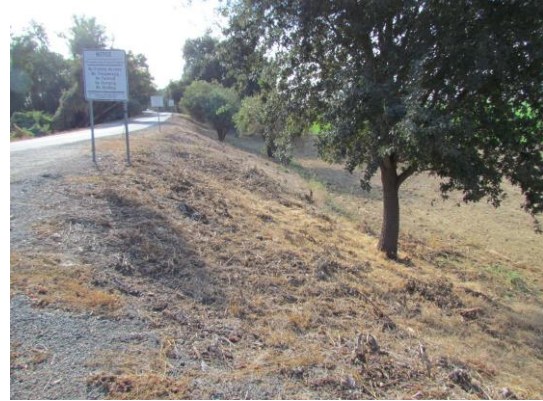
Photo 1 of 1 : FA_2015_RD0307_166_62_20151019_00033.jpg

Looking downstream from levee mile 0.00 land side slope.

LM Start	0.00	Rating **	A	Issue No.	63
LM End	6.56	Issue Type +	Ma	Location *	WS
Category	Earthen Levee			GPS Latitude/Longitude	
				Start	End
Item	Vegetation			38.480023 °	38.429775 °
				-121.549420 °	-121.533370 °
DWR ID	DWR_RD0307_01_f_2015_63				
Action/Comments					
Control annual grass and weeds on the levee slopes and easements. Inspector Comments: The RD has contracted for the levee slopes to be cleared of unwanted vegetation from levee mile 0.00 thru 6.65 waterside.

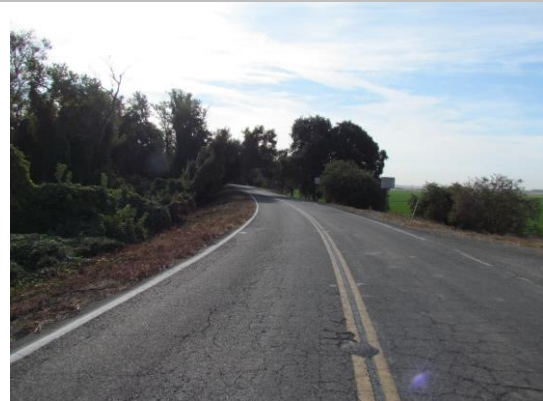
Photo 1 of 1 : FA_2015_RD0307_166_63_20151019_00032.jpg

Looking downstream from the waterside levee slope levee mile 0.00.

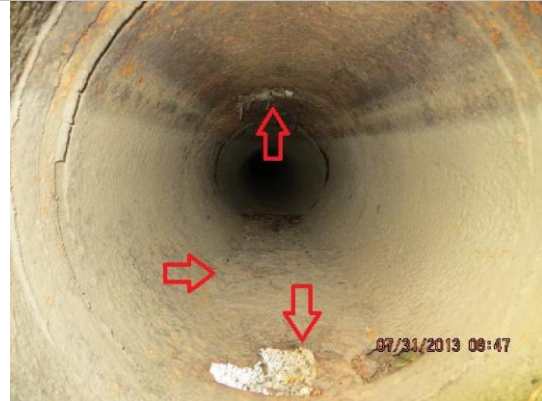
Photo 1 of 3 : UCIP_FA_2015_1384.jpg

Inspector Comments: FS_ID:42934
 DS_ID:21657
 EP_NO: N/A
 FS_HLM: 0.454
 Repair Type: Urgent
 Crossing Status: Found
 UCIP Comments: Pipe heavily corroded and will likely need replacement if 15-inch pipe sleeved through it needs replacement. Annular space not grouted between two pipes.
 FIELD_STRUCT_DESC: 20-inch steel irrigation pipe through the levee 16.7 feet below the crown. 15-inch pipe sleeved through this pipe. Pump missing from abandoned steel pier on WS toe. Walkway from shoulder to pier missing or abandoned. Originally included in the 1959 O&M manual.
 FS Date: 07/31/2013

Holes and corrosion shown inside 15-inch pipe sleeved through this pipe.

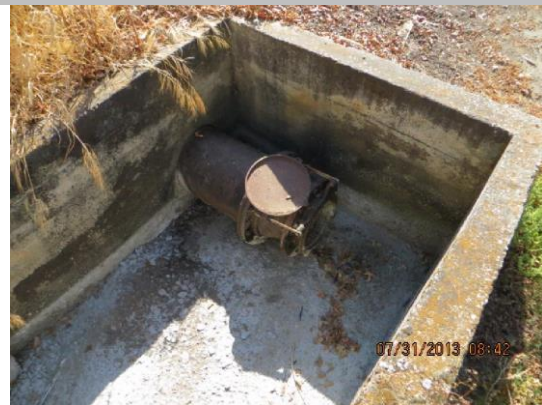
Photo 2 of 3 : UCIP_FA_2015_1385.jpg

Pipe at outlet on LS toe.

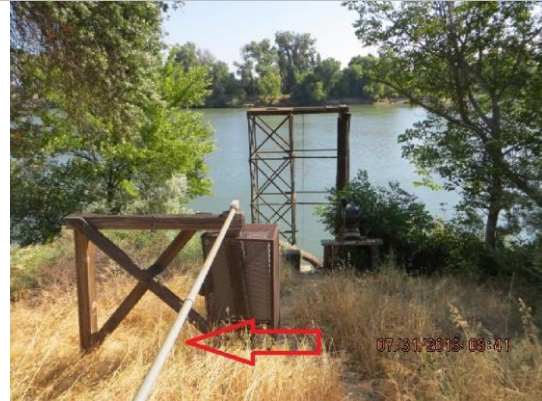
Photo 3 of 3 : UCIP_FA_2015_1386.jpg

LM Start	0.45	Rating **	U	Issue No.	69 (cont)
LM End	0.45	Issue Type +	En	Location *	WS
Category	Supplemental			GPS Latitude/Longitude	
				Start	End
Item	DWR UCIP Field Study			38.475542 °	38.475542
				-121.543566 °	-121.543566
DWR ID					
Action/Comments					
Inspector Comments: FS_ID:42934 DS_ID:21657 EP_NO: N/A FS_HLM: 0.454 Repair Type: Urgent Crossing Status: Found

Abandoned walkway and metal pier on WS slope.

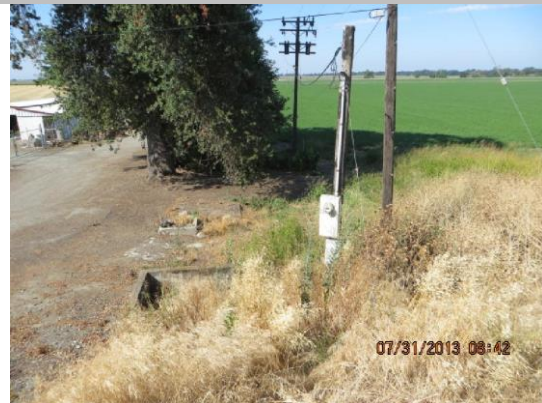
Photo 1 of 3 : UCIP_FA_2015_1361.jpg

LM Start	0.45	Rating **	U	Issue No.	70
LM End	0.45	Issue Type +	En	Location *	WS
Category	Supplemental			GPS Latitude/Longitude	
				Start	End
Item	DWR UCIP Field Study			38.475542 °	38.475542 °
				-121.543566 °	-121.543566 °
DWR ID					
Action/Comments					
Inspector Comments: FS_ID:16743 DS_ID:21656 EP_NO: N/A FS_HLM: 0.454 Repair Type: Urgent Crossing Status: Found UCIP Comments: Pipe heavily corroded at outlet on LS toe. Holes on bottom of pipe at outlet and internal circumference shows heavy exfoliation. Pipe failing internally. Recommend replacement or video inspection before continuing use. FIELD_STRUCT_DESC: 1 of 2: 15-inch steel irrigation pipe sleeved through 21-inch steel conduit, through the levee 16.7 feet below crown. Slant pump, gate valve, concrete headwall, electrical control pane, and abandoned pier on WS slope. Concrete U-shaped outlet with flap gate on LS toe. Service pole on the landward slope with anchor. FS Date: 07/31/2013

Concrete U-shaped outlet, JP, and meter on LS toe.

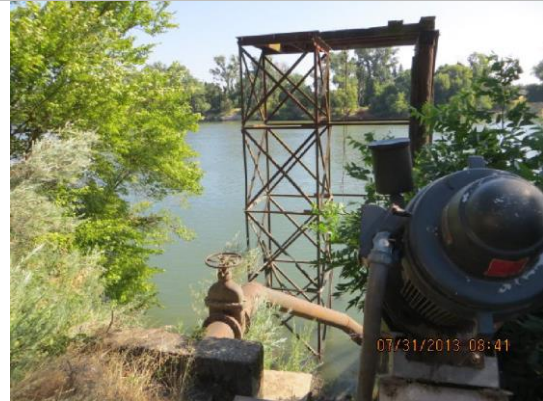
Photo 2 of 3 : UCIP_FA_2015_1362.jpg

Pipe, gate valve, pump, and abandoned metal pier on WS slope.

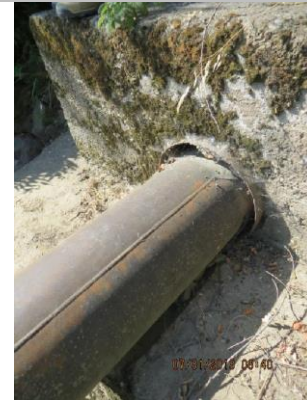
Photo 3 of 3 : UCIP_FA_2015_1363.jpg

15-inch pipe sleeved through 21-inch pipe on WS slope at headwall.

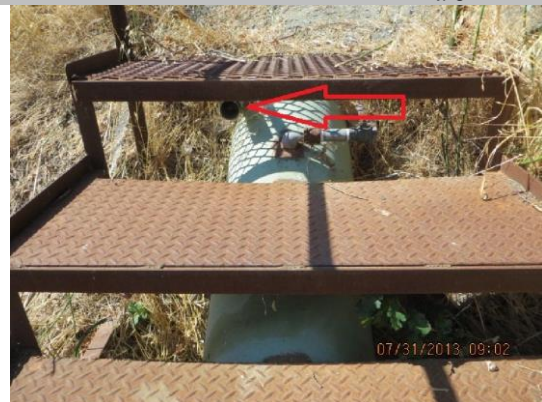
Photo 1 of 3 : UCIP_FA_2015_0996.jpg

LM Start	0.92	Rating **	M	Issue No.	71
LM End	0.92	Issue Type +	En	Location *	WS
Category	Supplemental			GPS Latitude/Longitude	
				Start	End
Item	DWR UCIP Field Study			38.472872 °	38.472872 °
				-121.535542 °	-121.535542 °
DWR ID					
Action/Comments					
Inspector Comments: FS_ID:17103 DS_ID:24014 EP_NO: 18229 FS_HLM: 0.937 Repair Type: Non-Urgent Crossing Status: Found UCIP Comments: Pipe open on both ends. Need to install caps. FIELD_STRUCT_DESC: 2 of 2: 2-inch galvanized iron pipe through the levee 2.0 feet below the crown (Permit No. 18229, 2007). FS Date: 07/31/2013

Conduit visible under first step of walkway to pump on WS shoulder.

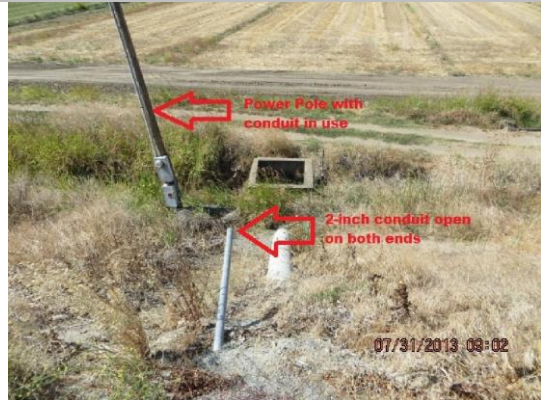
Photo 3 of 3 : UCIP_FA_2015_0998.jpg

Conduit visible 2-feet below the crown on the LS shoulder.

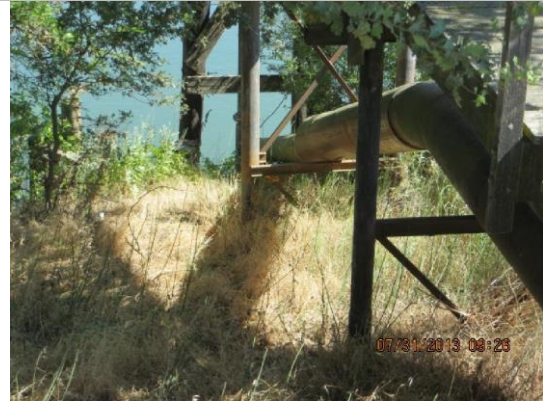
Photo 1 of 3 : UCIP_FA_2015_1387.jpg

LM Start	1.07	Rating **	M	Issue No.	72
LM End	1.07	Issue Type +	En	Location *	WS
Category	Supplemental			GPS Latitude/Longitude	
				Start	End
Item	DWR UCIP Field Study			38.472870 °	38.472870 °
				-121.532750 °	-121.532750 °
DWR ID					
Action/Comments					
Inspector Comments: FS_ID:16764					
DS_ID:21659					
EP_NO: 8012					
FS_HLM: 1.09					
Repair Type: Non-Urgent					
Crossing Status: Found

Pipe visible under wooden walkway on WS slope.

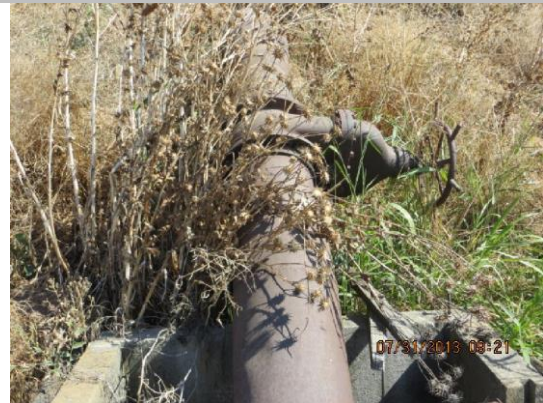
Photo 2 of 3 : UCIP_FA_2015_1388.jpg

Pipe, gate valve, and concrete distribution box on LS toe.

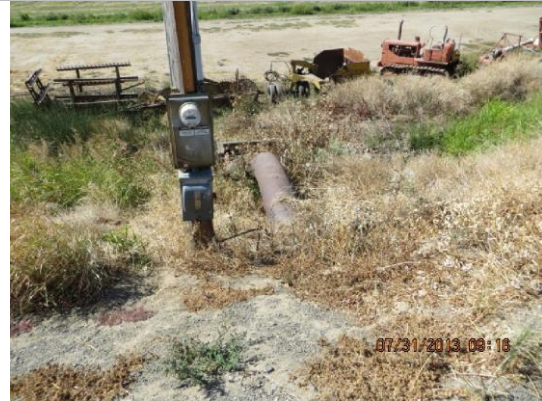
Photo 3 of 3 : UCIP_FA_2015_1395.jpg

Pipe and JP/meter on LS slope.

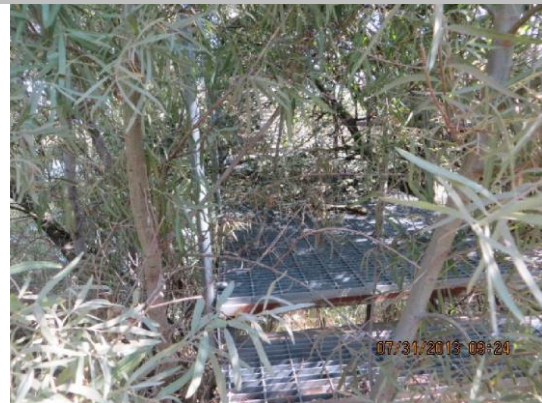
Photo 1 of 3 : UCIP_FA_2015_1396.jpg

Metal walkway visible in brush on WS slope.

Inspector Comments: FS_ID:16766
 DS_ID:21660
 EP_NO: 3324
 FS_HLM: 1.098
 Repair Type: Non-Urgent
 Crossing Status: Found
 UCIP Comments: Walkway completely obscured by vegetation on WS slope.
 FIELD_STRUCT_DESC: 1.25-inch electrical conduit through the levee 10.0 feet below the crown. Corrugated metal stage recorder house and walkway on the waterward slope. Service pole on the landward slope (Permit No. 3324, 1960).
 FS Date: 07/31/2013

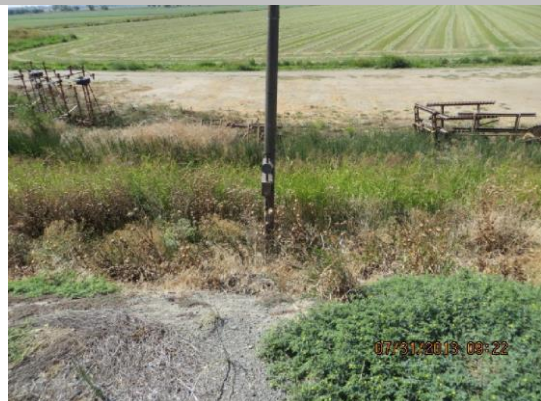
Photo 3 of 3 : UCIP_FA_2015_1398.jpg

Conduit visible at base of JP on LS toe.

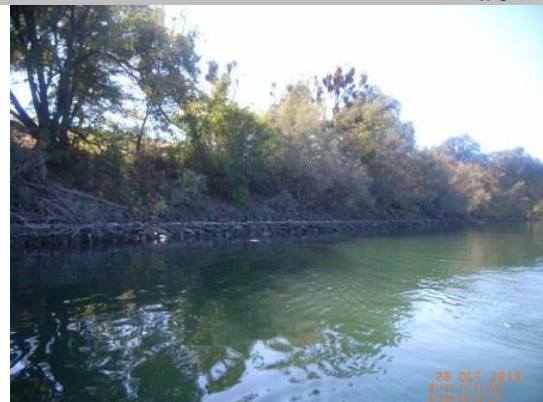
Photo 1 of 1 : USACE2013A_SAC_48-6_R_4.jpg

LM Start	1.17	Rating **	M	Issue No.	1
LM End	1.31	Issue Type +	Ma	Location *	WS
Category	Supplemental			GPS Latitude/Longitude	
				Start	End
Item	2015 USACE Erosion Survey, DRAFT			38.473059 °	38.473082 °
				-121.530988 °	-121.528437 °
DWR ID					
Action/Comments					
Inspector Comments: 2012 - Bank is slowly eroding, old rock protection starting to unravel. 2015: No observed changes. [2015 Site ID: SAC_48-6_R]

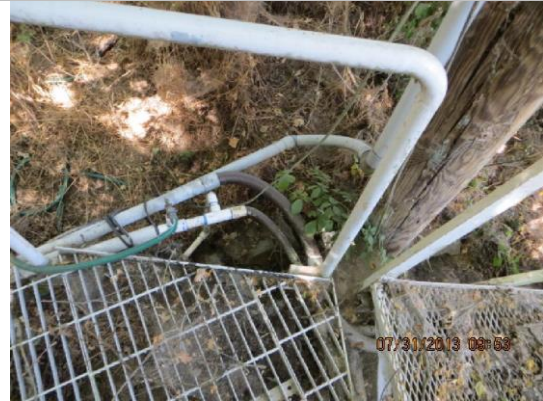
Photo 1 of 3 : UCIP_FA_2015_0999.jpg

LM Start	1.62	Rating **	M	Issue No.	74
LM End	1.62	Issue Type +	En	Location *	WS
Category	Supplemental			GPS Latitude/Longitude	
				Start	End
Item	DWR UCIP Field Study			38.473129 °	38.473129 °
				-121.522717 °	-121.522717 °
DWR ID					
Action/Comments					
Inspector Comments: FS_ID:17105 DS_ID:24017 EP_NO: N/A FS_HLM: 1.643 Repair Type: Non-Urgent Crossing Status: Found UCIP Comments: No permit identified for crossing or boat dock/steel ramp. FIELD_STRUCT_DESC: 2 of 2: 1.5-inch PVC pipe through the levee 2-feet below the crown. Metal walkway/pier on WS slope. Possible pump on LS slope with filter tanks. FS Date: 07/31/2013

Pipes visible under walkway on WS slope.

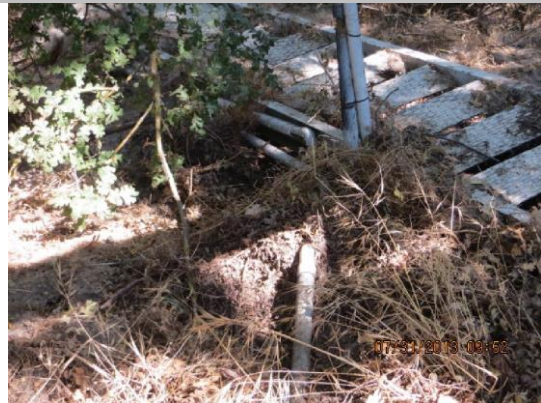
Photo 2 of 3 : UCIP_FA_2015_1003.jpg

Pipes visible on WS shoulder at metal ramp.

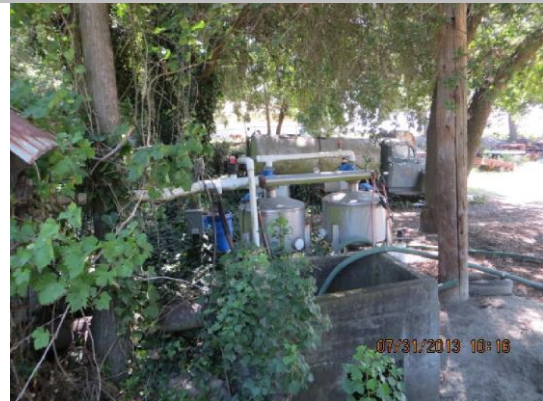
Photo 1 of 2 : UCIP_FA_2015_1438.jpg

LM Start	1.82	Rating **	M	Issue No.	76
LM End	1.82	Issue Type +	En	Location *	LS
Category	Supplemental			GPS Latitude/Longitude	
				Start	End
Item	DWR UCIP Field Study			38.473249 °	38.473249 °
				-121.519095 °	-121.519095 °
DWR ID					
Action/Comments					
Inspector Comments: FS_ID:16805 DS_ID:21663 EP_NO: 8016 FS_HLM: 1.842 Repair Type: Non-Urgent Crossing Status: Indicator Found UCIP Comments: Needs to be abandoned properly. FIELD_STRUCT_DESC: *Abandoned* 8-inch iron pipe through the levee 15.7 feet below the crown. No connection in pump house on the LS toe, but 8-inch outlet pipe remains at connection from pumphouse to concrete standpipe. (Permit No. 8016, 1972). Pipe capped at both ends according to Permit No. 18209 for replacement pipe. Originally included in the 1959 O&M manual. FS Date: 07/31/2013

Concrete distribution box at LS toe.

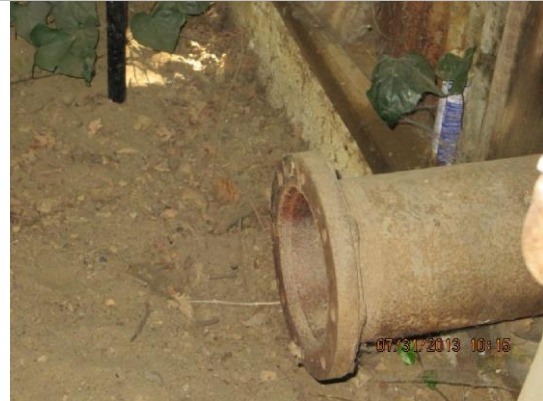
Photo 2 of 2 : UCIP_FA_2015_1439.jpg

Remnants of abandoned pipe visible in pumphouse on LS toe.

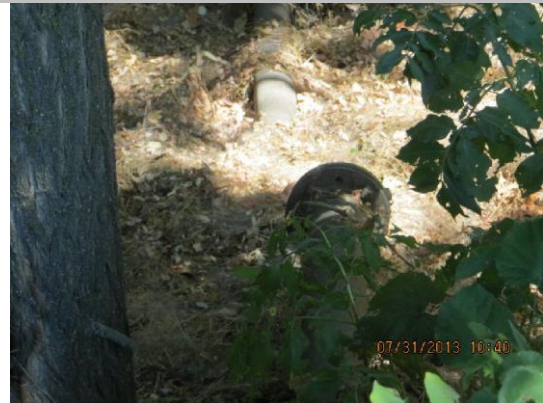
Photo 1 of 3 : UCIP_FA_2015_2464.jpg

LM Start	2.21	Rating **	M	Issue No.	77
LM End	2.21	Issue Type +	En	Location *	LS
Category	Supplemental			GPS Latitude/Longitude	
				Start	End
Item	DWR UCIP Field Study			38.472238 °	38.472238 °
				-121.512032 °	-121.512032 °
DWR ID					
Action/Comments					
Inspector Comments: FS_ID:22709 DS_ID:21665 EP_NO: N/A FS_HLM: 2.238 Repair Type: Non-Urgent Crossing Status: Found UCIP Comments: Pipe abandoned and should be done so properly. FIELD_STRUCT_DESC: 5-inch steel irrigation pipe through the levee 2.0-feet below the crown. Pipe open on both ends. Originally included in the 1959 O&M manual. FS Date: 07/31/2013

Pipe visible on WS slope.

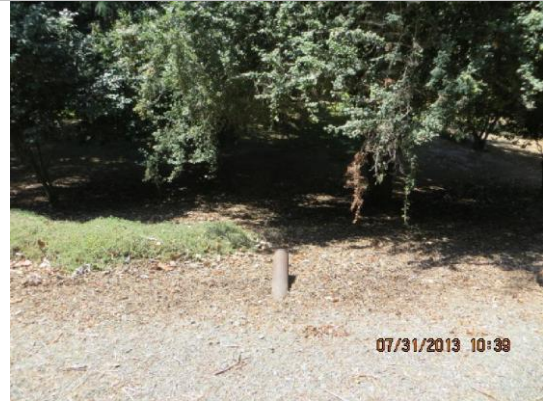
Photo 2 of 3 : UCIP_FA_2015_2465.jpg

Pipe visible on LS shoulder.

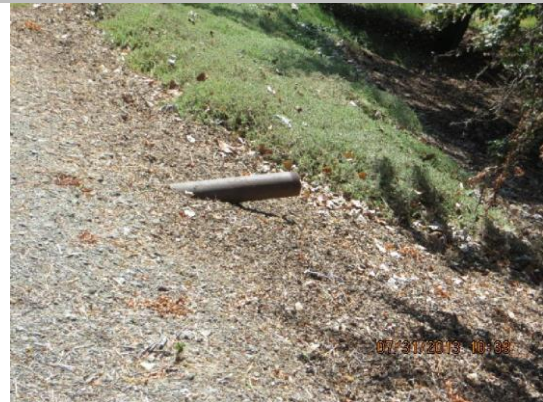
Photo 3 of 3 : UCIP_FA_2015_2466.jpg

Pipe visible on LS shoulder.

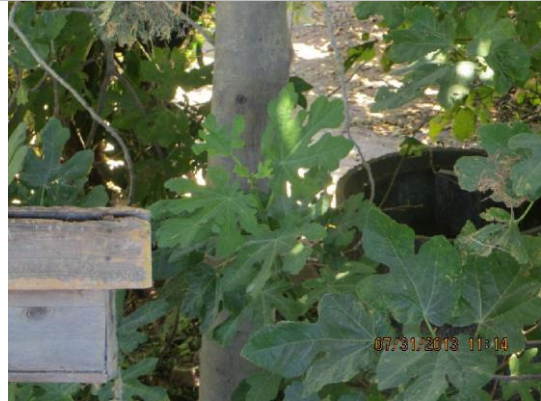
Photo 1 of 3 : UCIP_FA_2015_1443.jpg

36-inch concrete standpipe on LS toe.

Inspector Comments: FS_ID:40794
 DS_ID:21667
 EP_NO: N/A
 FS_HLM: 2.452
 Repair Type: Non-Urgent
 Crossing Status: Found
 UCIP Comments: Pipe appears abandoned and if so should be done so properly.
 FIELD_STRUCT_DESC: 6-inch steel irrigation pipe through the levee 3.0 feet below the crown. Pump and gate valve on the waterward slope. 36-inch concrete standpipe on LS toe. Originally included in the 1959 O&M manual.
 FS Date: 07/31/2013

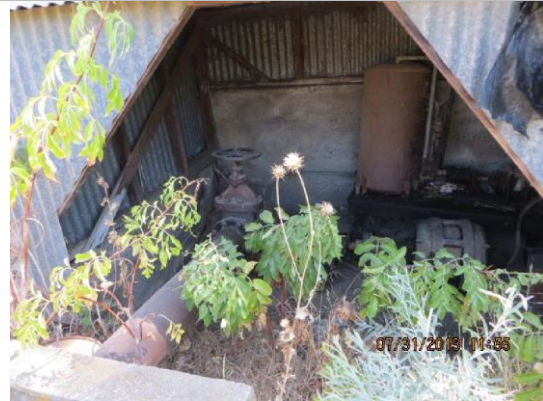
Photo 1 of 2 : UCIP_FA_2015_1463.jpg

LM Start	2.73	Rating **	M	Issue No.	79
LM End	2.73	Issue Type +	En	Location *	WS
Category	Supplemental			GPS Latitude/Longitude	
				Start	End
Item	DWR UCIP Field Study			38.467404 °	38.467404 °
				-121.505681 °	-121.505681 °
DWR ID					
Action/Comments					
Inspector Comments: FS_ID:16815 DS_ID:21671 EP_NO: 8023 FS_HLM: 2.763 Repair Type: Non-Urgent Crossing Status: Found UCIP Comments: Appears abandoned and should be done so properly. FIELD_STRUCT_DESC: 8-inch steel irrigation pipe through the levee 13.7 feet below the crown. Pump and gate valve in pump house on the landward toe. 4'X2.5' concrete distribution box off LS toe. Service pole and anchor on the landward slope (Permit No. 8023, 1972). Included in the 1959 O&M manual. FS Date: 07/31/2013

Pump and gatevalve inside pumphouse on LS toe.

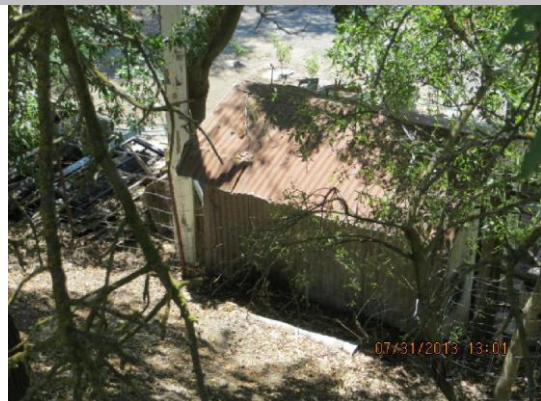
Photo 2 of 2 : UCIP_FA_2015_1466.jpg

Pumphouse on LS toe. No access due to fence along toe.

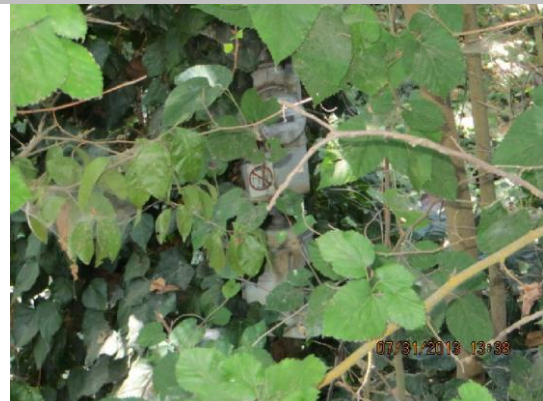
Photo 1 of 3 : UCIP_FA_2015_1072.jpg

Meter on JP at LS toe covered with vegetation/IVY.

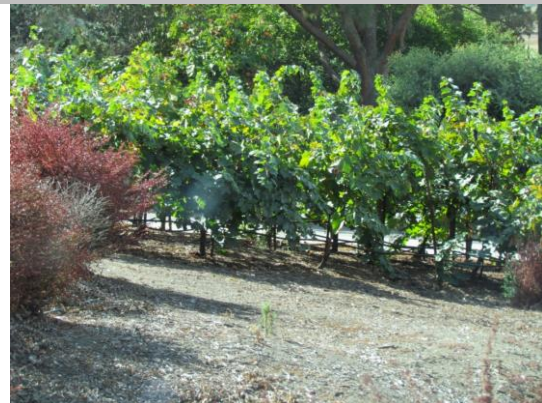
Photo 1 of 1 : FA_2015_RD0307_166_27_20150915_00005.jpg

Unwanted grapes placed on levee slope, these grapes has been reported to both district and CVFPB. No permit.

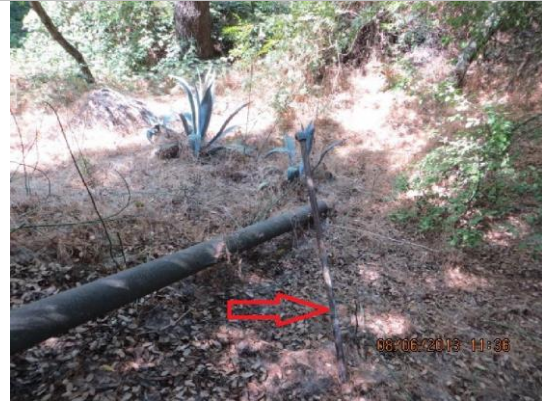
Photo 1 of 1 : UCIP_FA_2015_2077.jpg

Abandoned electrical conduit next to pipe on LS slope.

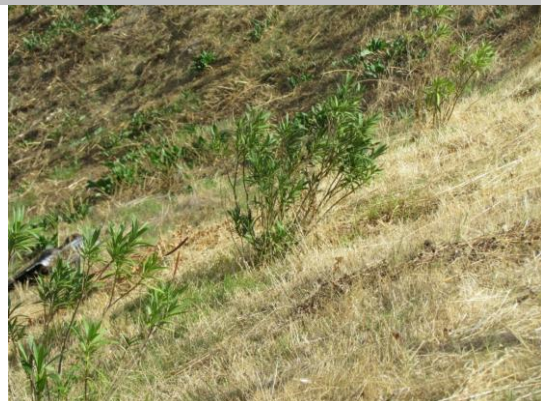
Photo 2 of 4 : FA_2015_RD0307_166_28_20150915_00007.jpg

15 Oleander trees planted on the landside levee slope, no permit. Looking upstream from levee mile 5.33-5.44.

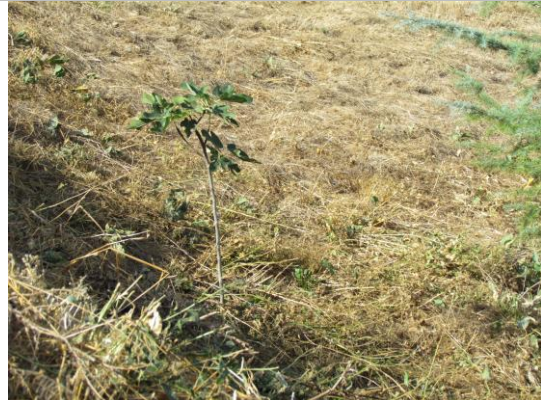
Photo 4 of 4 : FA_2015_RD0307_166_28_20151019_00035.jpg

The landowner has planted small fig trees on the levee toe.

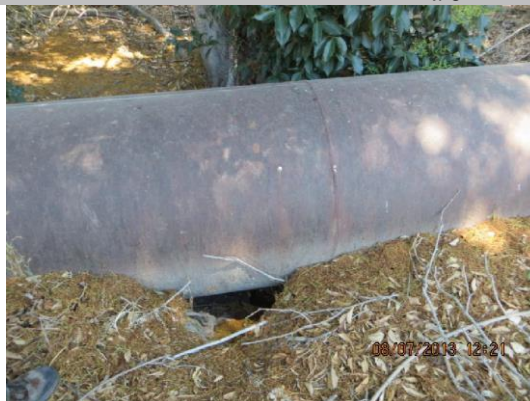
Photo 3 of 3 : UCIP_FA_2015_1665.jpg

Animal activity/burrows under pipe on LS at various locations.
